Docket No. 217 – Development and Management Plan Inspection

Northeast Utilities Service Company Certificate of Environmental Compatibility and Public Need for the construction of a 345-kV electric transmission line and reconstruction of an existing 115-kV electric transmission line between Connecticut Light and Power Company's Plumtree Substation in Bethel, through the towns of Redding, Weston, and Wilton, and to the Norwalk Substation in Norwalk, Connecticut.

Date: October 12, 2005

Location: Transition Stations: Hoyts Hill, Archers Lane, Norwalk Junction

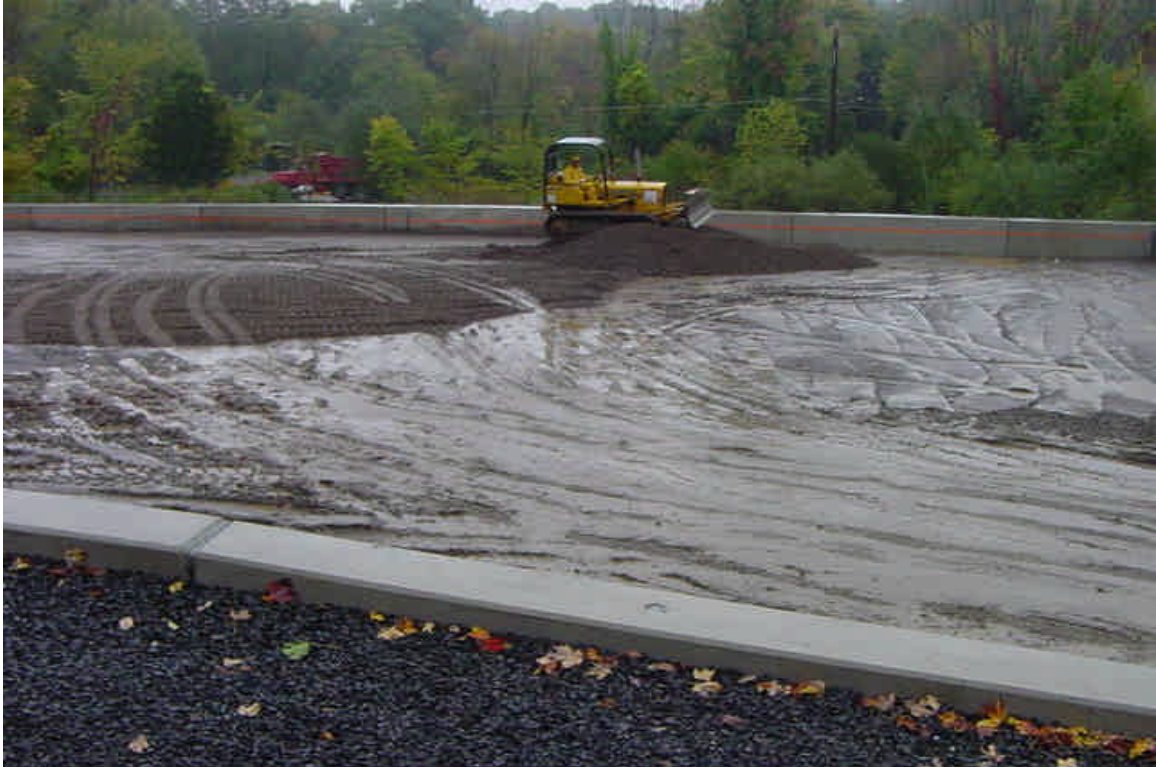
Hoyts Hill Transition Station: View of the continued backfill and compacting within the retaining wall/foundation of the site. (10/12/05)

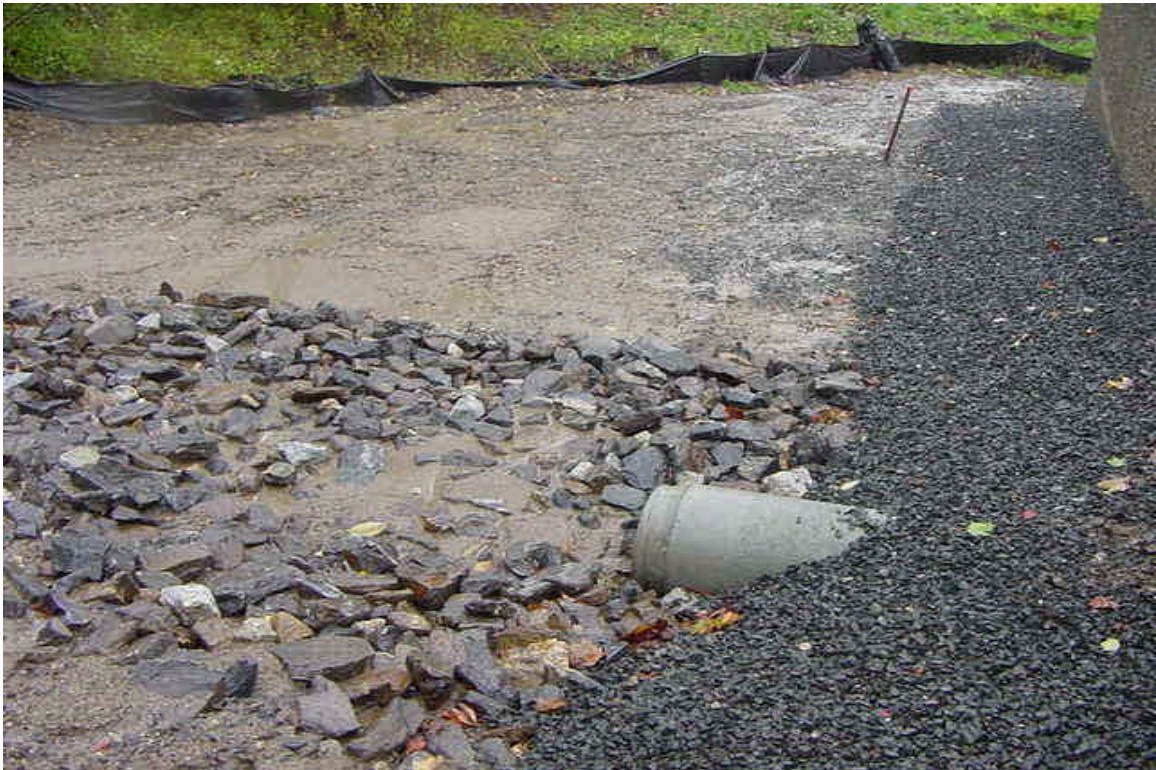
The outlet pipe and the dissipater pad were working well during the rain storm. The silt fence at this northern portion of the site should be repaired. (10/12/05)

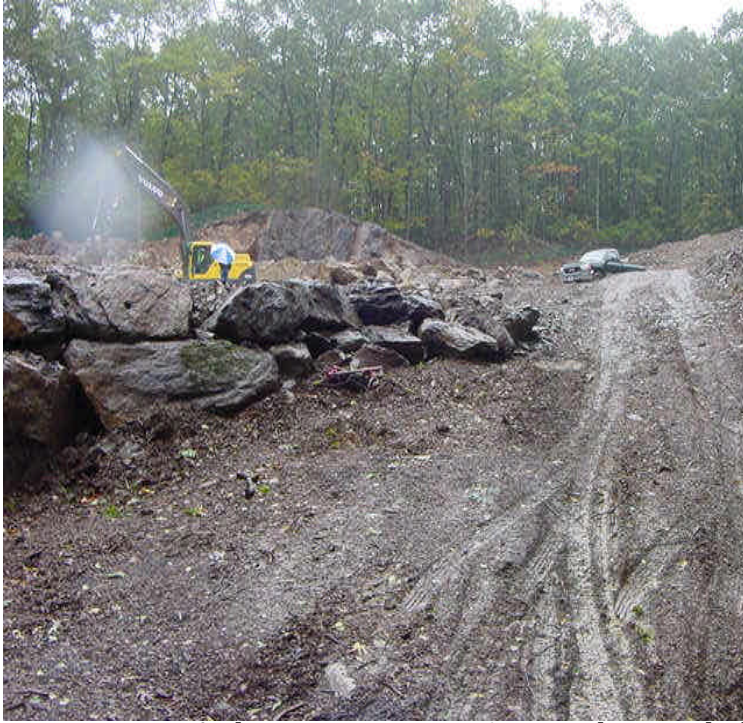
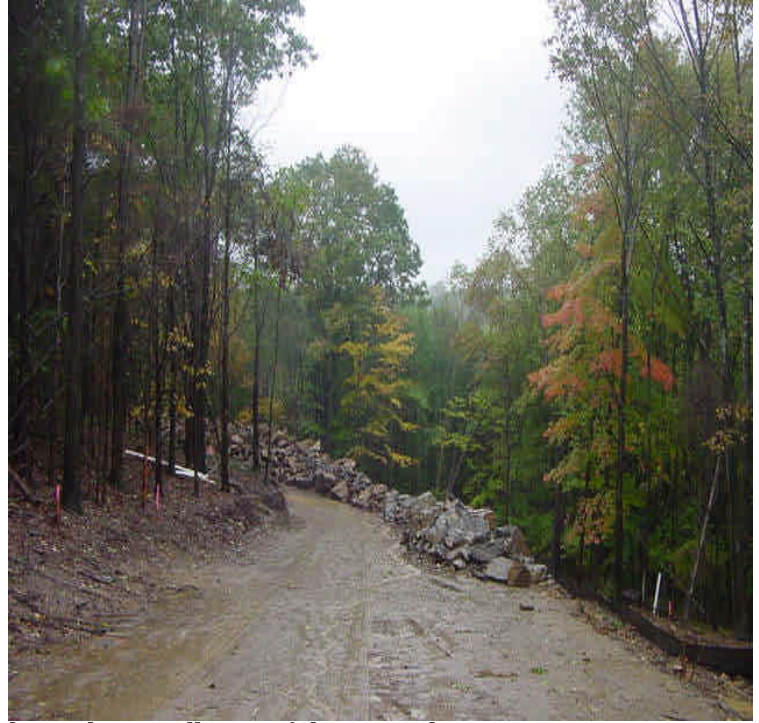
Archers Lane Transition Station: Photo on the left shows the overall view of the site and continues earthwork. Photo on the left shows the current view of the access road into the site. (10/12/05)

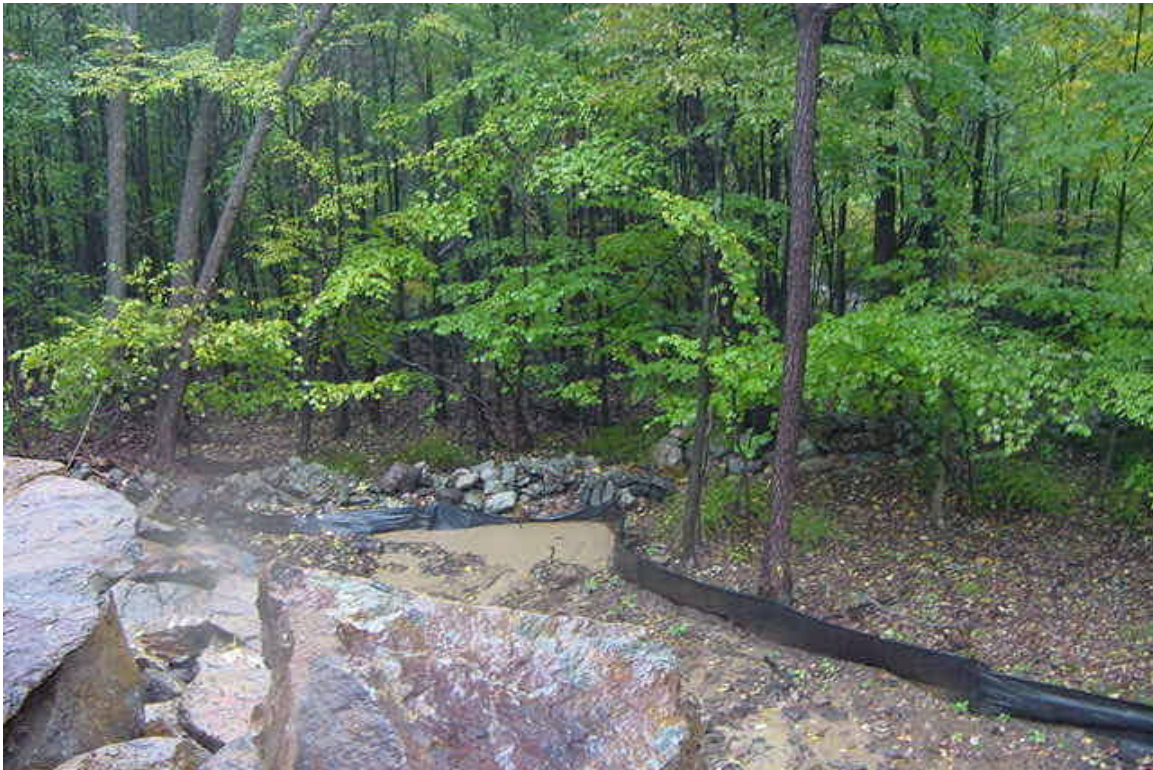
Turbid runoff from the access road is pooling at the low spot in the silt fence. The fence appears to be containing most of the water at this time but this spot should be maintained if necessary due to the stress of the storm. (10/12/05)

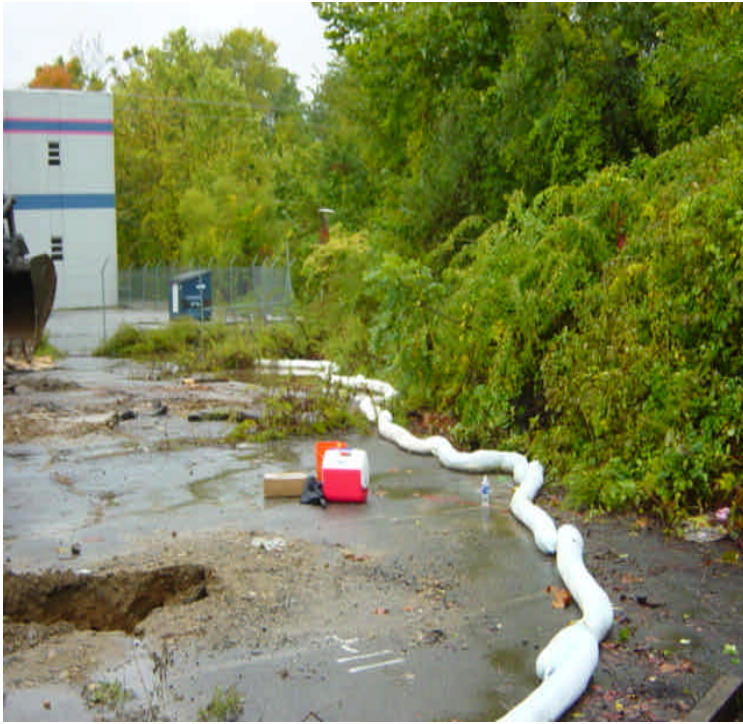
Norwalk Junction Transition Station: Some of the work left over is from 115kV work on the site. Photo on the left shows absorbent booms in place after a reported emptying of a frac truck used for dewatering occurred. Photo on the right shows left over haybales from a stockpile area. (10/13/05)

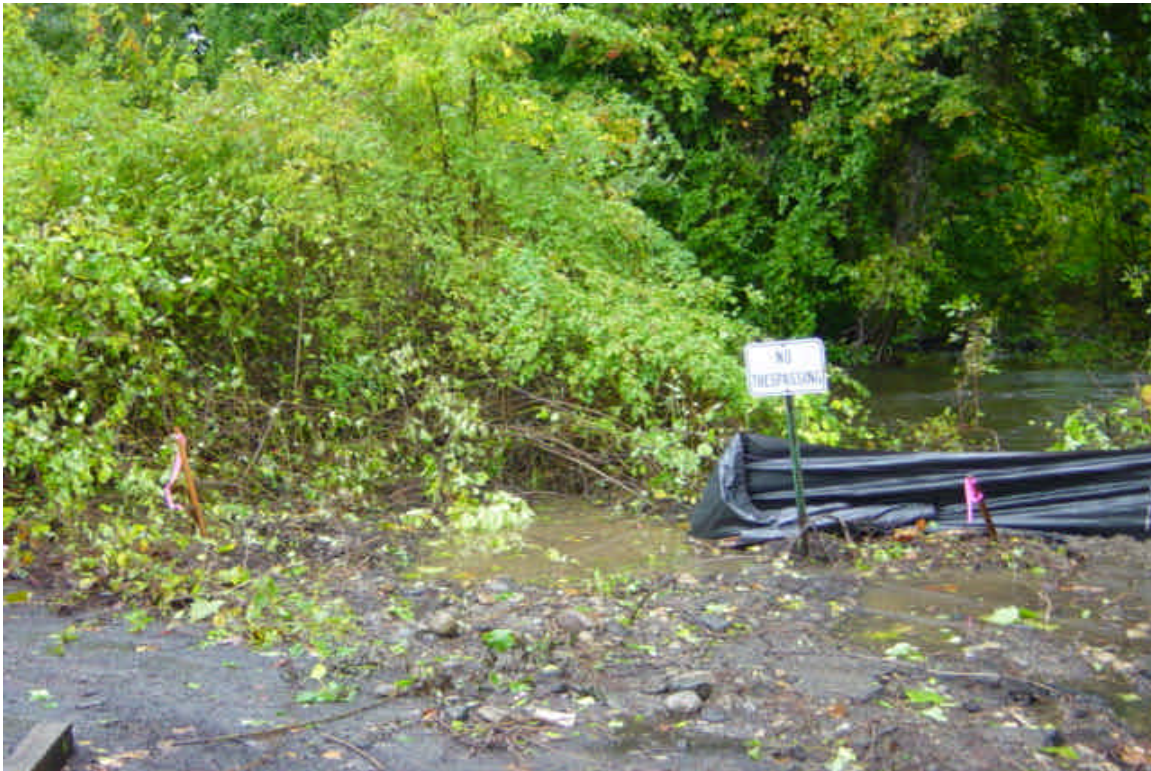
Due to the heavy rains, the Norwalk River had flooded into a portion of the site. Clearing and silt fence installation will continue as the transition station work gets going. (10/13/05)
